AUCKLAND TRANSPORT

Clonbern Road Carpark

Monthly Monitoring Inspection Report September 2018

September 2018

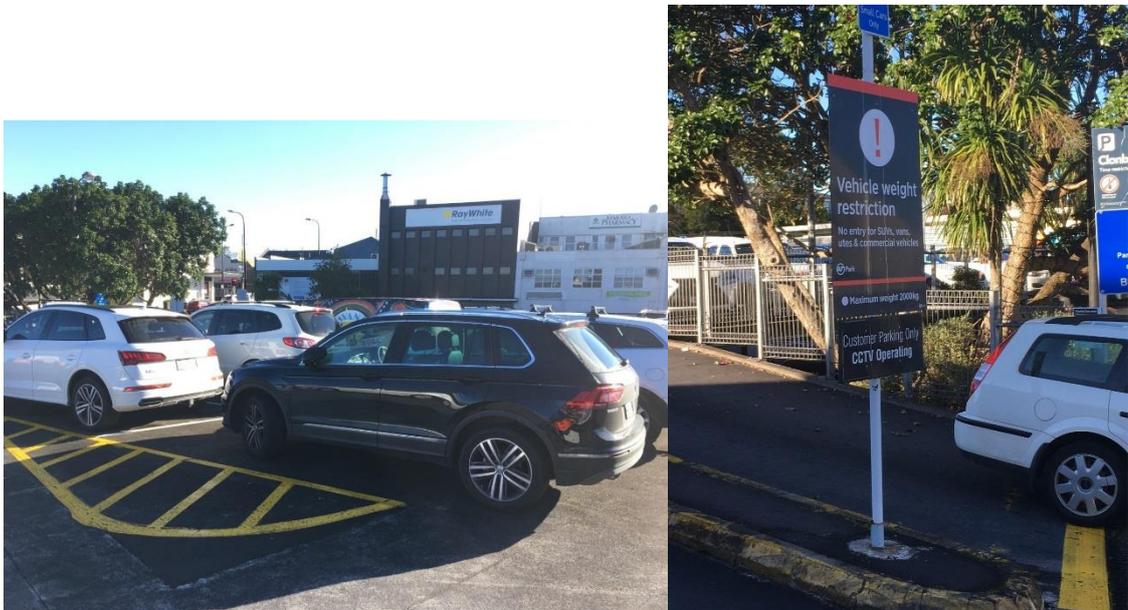
Figure 1: View of the upper level carpark and weight restriction

At the time of the monitoring inspection, and with new weight limit signage recently installed at the entrance to the upper carpark level, it was observed there were approximately 15 vehicles (SUV's, Vans) believed to be over the 2 tonne weight limit. GHD believes the current fencing to remove vehicle parking from 10.0 m south of Glidline B will remain in place.

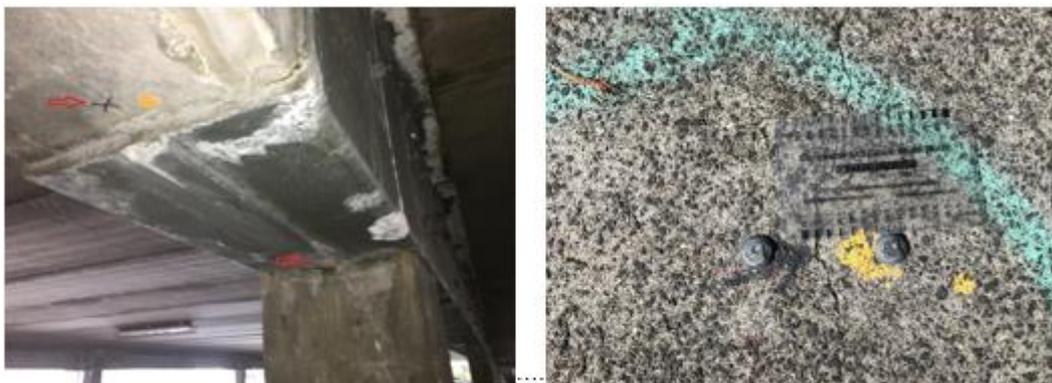
Figure 2: GHD deflection marking at IB2, IB3 and monitoring pins installed

- From an initial site inspection, it was difficult in locating the exact survey mark position of the points on the Level 1 roof soffit (hollow core units), and crack width locations from previous Opus monitoring (through faded markings on level 2 of the carpark). GHD cannot guarantee the exact measured location when using an inverted staff and crack width ruler for this initial survey inspection when comparing to the previous Opus results. GHD have therefore installed monitoring pins on the level 2 deck to ensure accurate monthly crack width measurements and clearly marked deflection points.

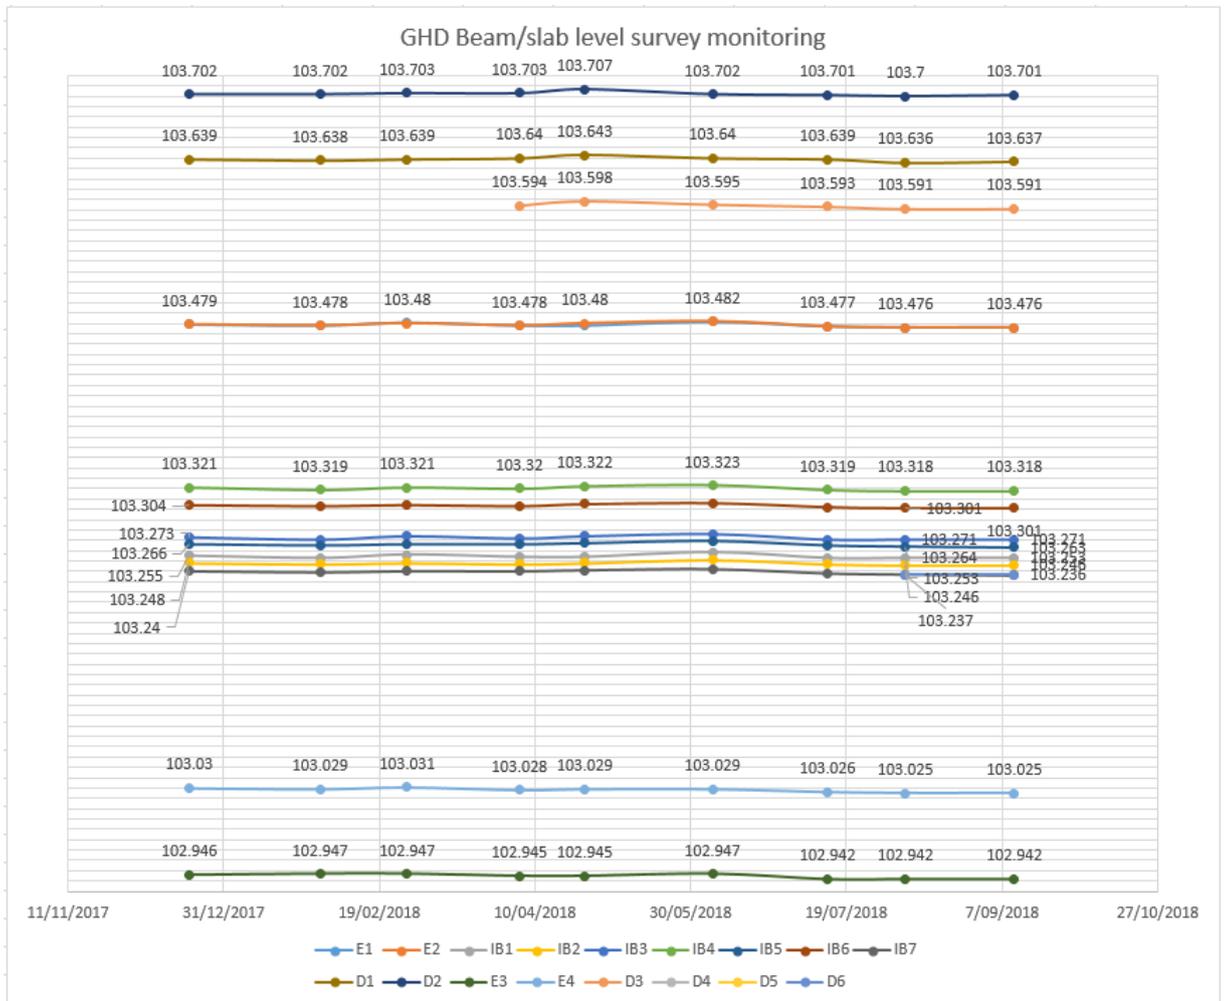
Figure 3: Overall beam/slab deflection monitoring curve

- As shown in figure 3, the maximum recorded deflection over a 9 month period was 4 mm at the end of cantilever beam (E3 - E4) at south western edge. This deflection has not changed since July 2018. The maximum incremental deflections from the start of monitoring (Opus October 2014) are at points D1 with 7 mm deflection and D2 with 5 mm of uplift readings when including the latest GHD September survey

- Monitoring point D1 and D2 have shown 2 mm and 1 mm deflection respectively; over 9 months since GHD have conducted monitoring. Previous Opus survey data alone (prior to GHD contract start) indicates for D1, D2 deflection of 6 mm and 5 mm respectively

- Location D3 (see Appendix A) has shown a 3 mm deflection since its initial monitoring at begin April 2018. There has been no change since the last reading on 7/8/2018

- Newly installed points (August period) at D4, D5, and D6 have shown 1mm change over the last month (D4).

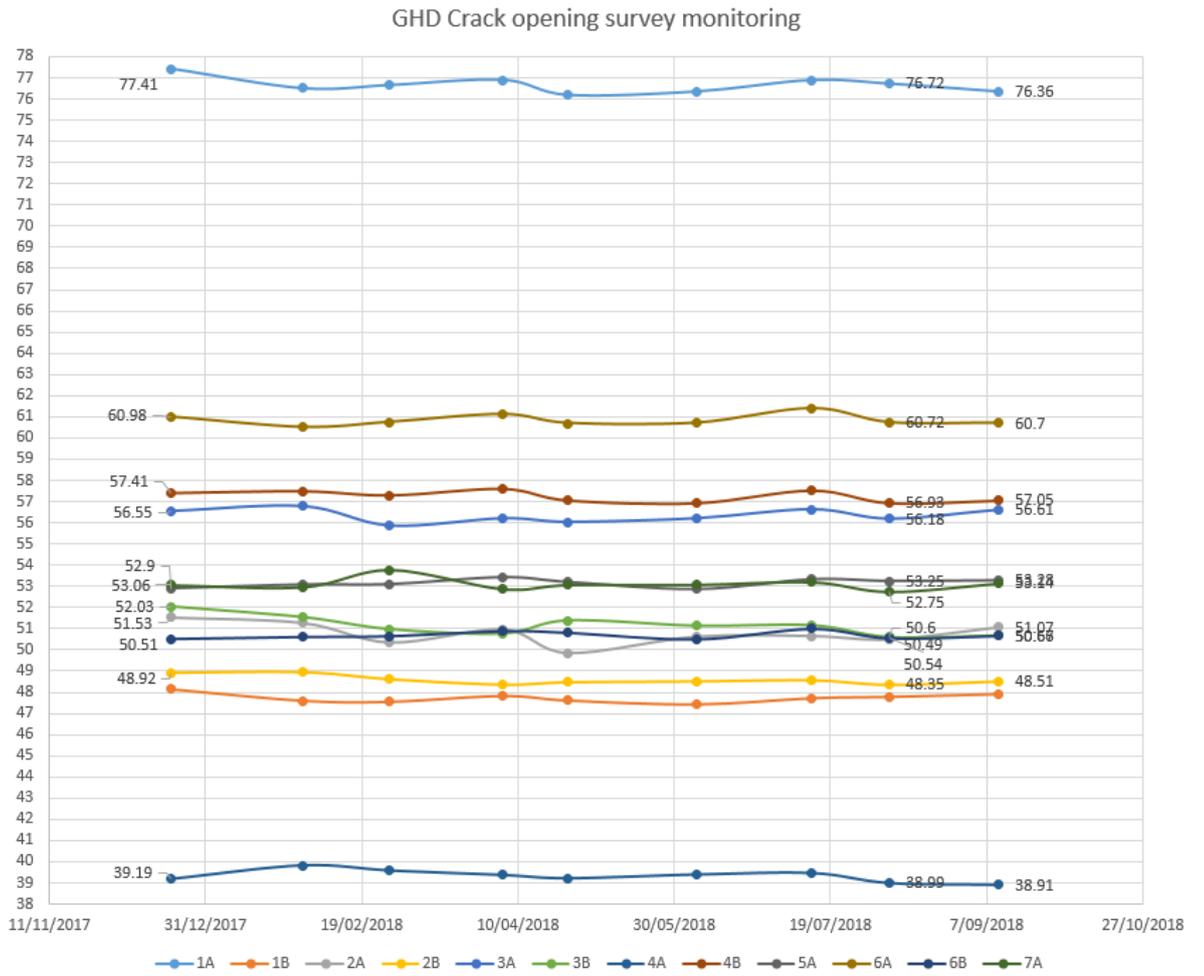
Figure 4: Overall crack width opening monitoring curve

- Of the targeted 12 crack locations, all indicated progressive crack width opening except 3A, 5A & 6B
- The largest crack opening width since the GHD December start readings was at locations 3B, with 1.36 mm crack opening width increase as shown in figure 4.

Based on 9 month GHD monitoring results shown in figure 4, crack widths were increased by 0.2 – 1.36 mm in differing locations. This result shows 0.38 mm crack closing which may be due to temperature effects, with the monitoring being conducted on top of the concrete surface. GHD however will closely monitor these locations including the continued survey of the full 29 monitoring locations around the carpark structure.

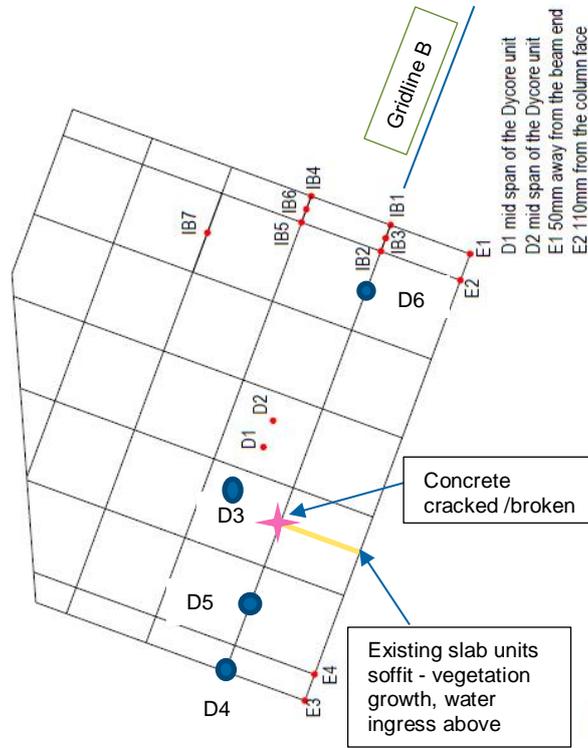
Appendix A – Site Layout Plan & Deflection Monitoring points location

Following a site visual check of the Level 1 hollow core units in early April, GHD included an additional monitoring location (D3) to check for further movement where the hollow core units at the joint line show differing levels and where vegetation growth at the butted joint is active. GHD have included a further three additional monitoring locations (D4, D5 D6) in the August survey along Gridline B (see Appendix A Layout Plan).

GHD recommends removal of the increased vegetation growth on the underside of the level 1 deck (see photo's 15 & 16) retaining the monitoring point, and clean, reseal of the joint above over a 10 metre length and concrete repair to the joint end intersection with Gridline B (see Appendix A, Layout plan).

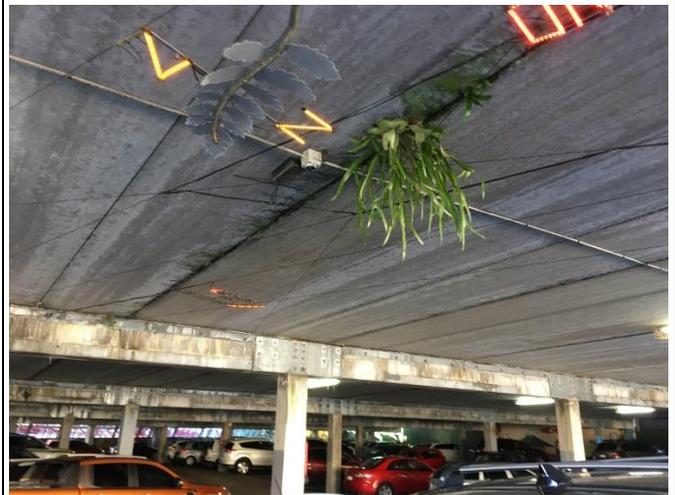
16. D3 – Water staining through joint with vegetation growth
